ASBESTOS SURVEY FOR FORT POINT U.S. COAST GUARD STATION

Presidio of San Francisco

September 1991

The Presidio of San Francisco
Phase II Environmental Study

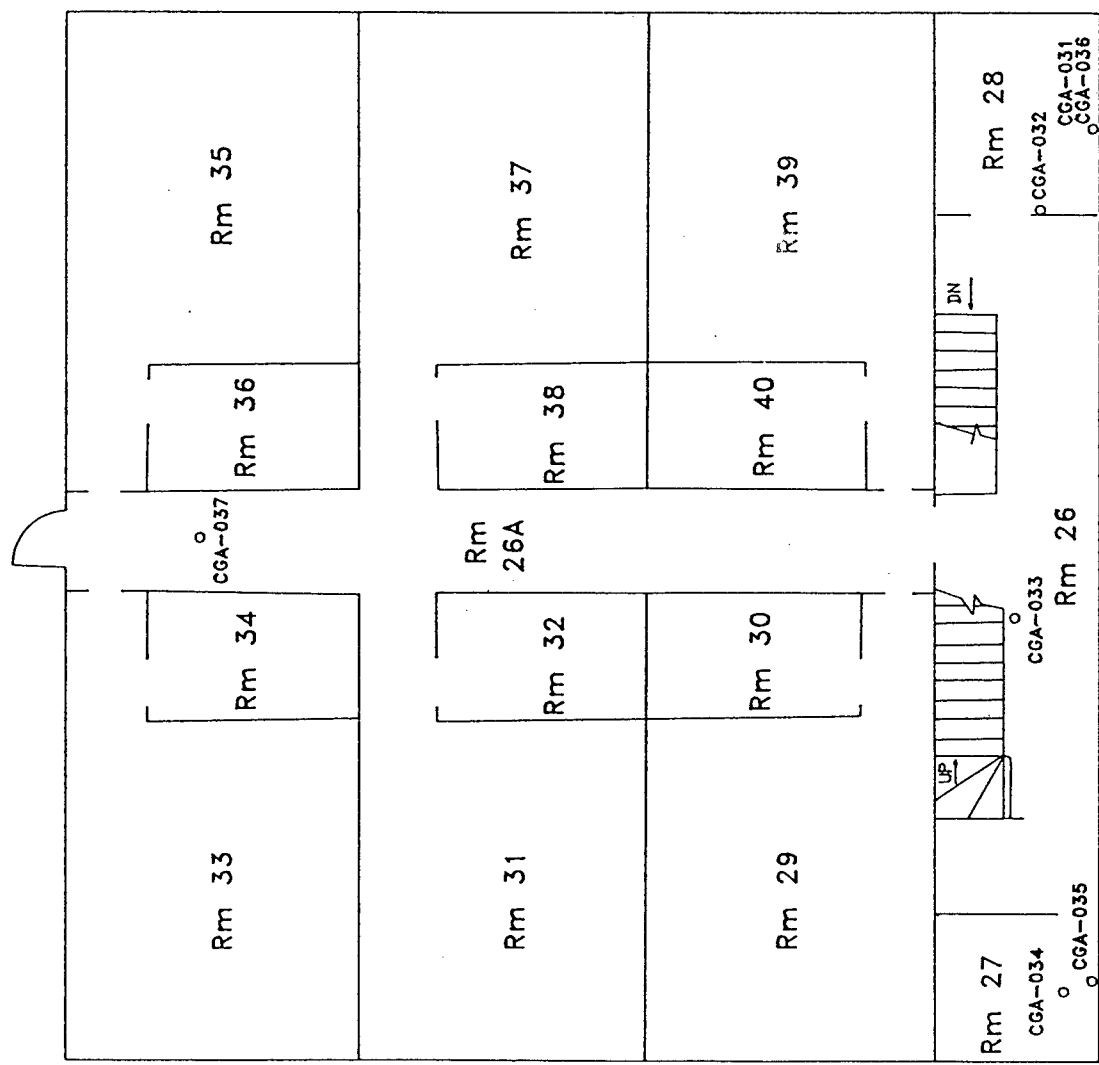
FLOOR PLAN & SAMPLE LOCATIONS
BLDG 991, FIRST FLOOR
FT. POINT U.S. COAST GUARD STATION
ASBESTOS SURVEY

Building 991 is the former station house, a four-story, wood-frame structure with wood shake siding and roof, and has been recently reoccupied. A total of 75 functional areas including 55 rooms and closets, one crawl space, and 19 functional areas above ceiling panels were inspected. A total of 37 samples were collected, including 15 friable (table 3.1-1) and 22 nonfriable (table 3.1-2) samples, and sent to Versar for analysis. Figures 3.1-1 through 3.1-4 illustrate room and sample locations on each level. None of the friable samples collected tested positive for asbestos while one nonfriable sample tested positive. This sample, CGA-032, was a piece of linoleum floor material from the laundry room (Room 28, figure 3.1-2) and it contained 20 to 25 percent chrysotile asbestos. This particular type of floor material was found only in Room 28.

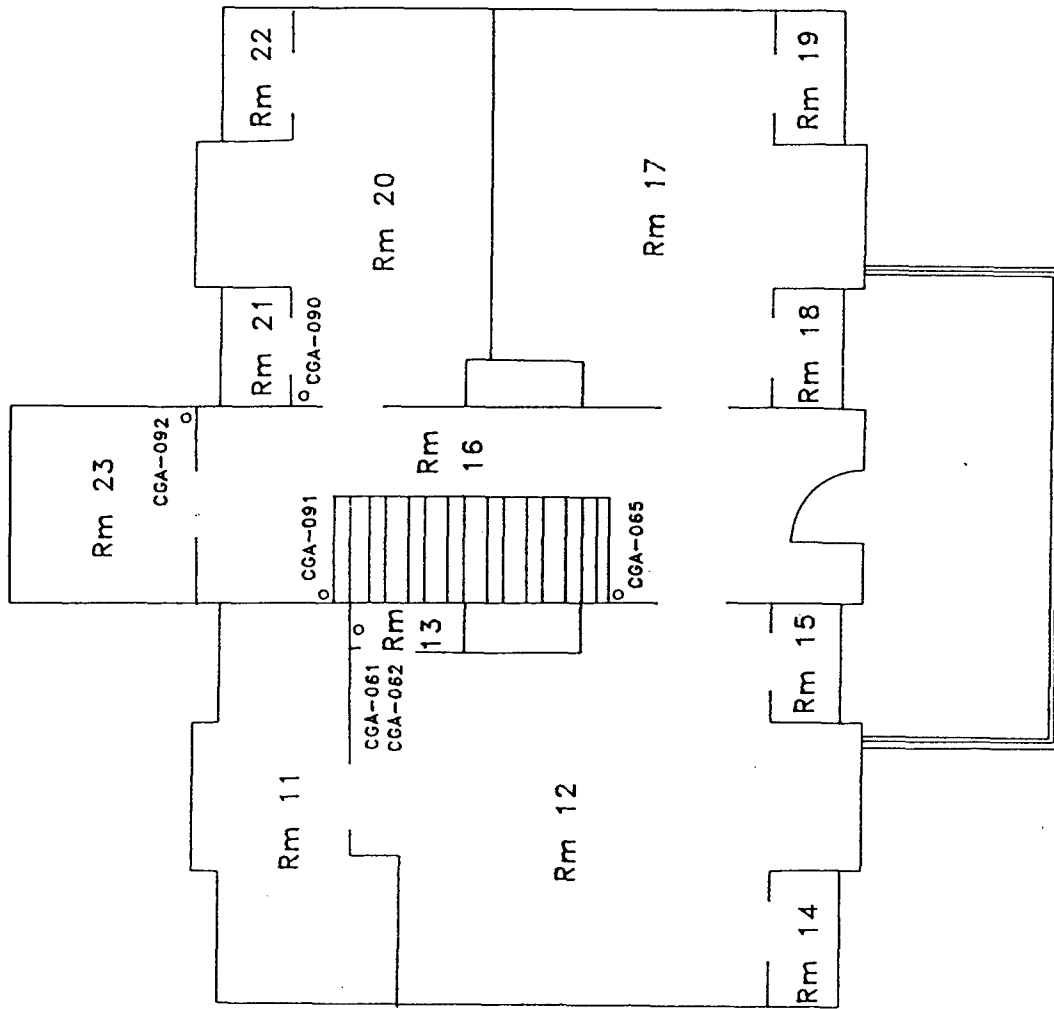
Figure 3.2-3

Sample CGA-065, collected on the second floor in Room 16 (figure 3.2-3), contained plaster which is present on the walls and ceilings of many of the rooms in the house. The sample also contained joint compound which is locally present around electrical fixtures. Analysis indicates 1-5 percent chrysotile asbestos in this sample. Asbestos was contained entirely within the joint compound while

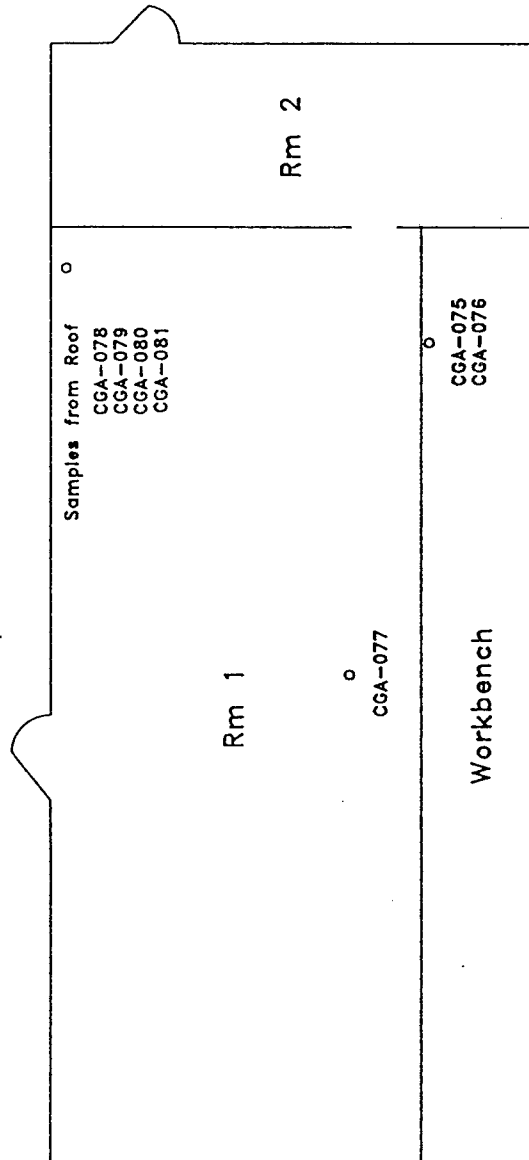
FLOOR PLAN & SAMPLE LOCATIONS
BLDG 998
FT. POINT U.S. COAST GUARD STATION
ASBESTOS SURVEY

Building 998 is a former maintenance shop, currently vacant, located at the end of the pier (figure 1.2-1). This building is a wood-frame, one-story structure with wood siding and asphalt shingles. A total of three functional areas including two rooms and an attic were inspected. A total of seven samples were collected, one friable (table 3.8-1) and six nonfriable (table 3.8-2), and sent to Versar for analysis. Figure 3.8-1 illustrates room and sample locations on each level of the structure. No asbestos was detected in the friable sample while one of the nonfriable samples tested positive. Sample CGA-075 from the counter top tile in Room 1 contained 1-5 percent chrysotile asbestos. This tile is found in no other location in the building.
